The Alaskan Way Seawall

The Alaskan Way Viaduct & Seawall Replacement Program

Why Replace the Viaduct and Seawall?

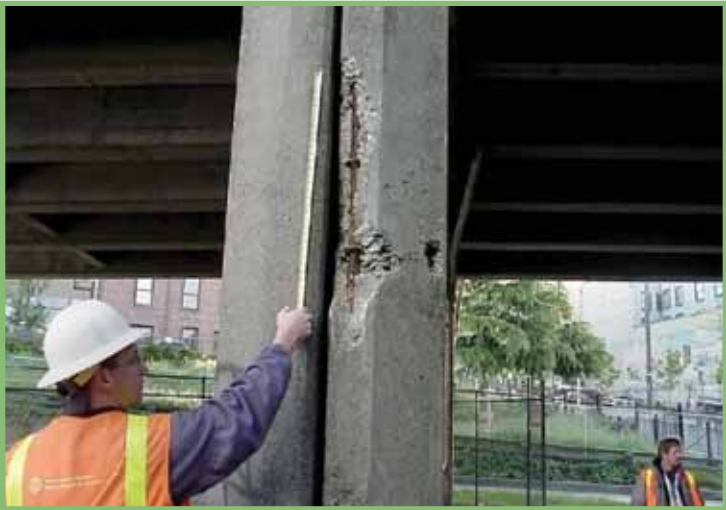
Engineer measuring damage on a viaduct support during an inspection.

Studies in the mid-1990s provided early evidence that the 1950s-era viaduct was nearing the end of its useful life. The viaduct's increasing age and vulnerability was apparent by crumbling concrete, exposed rebar, weakening column connections, and deteriorating railings.

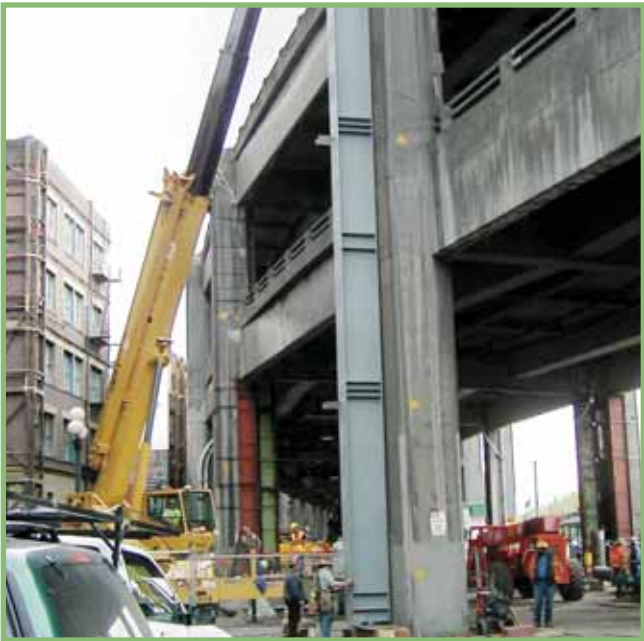
As WSDOT was evaluating the viaduct, the 2001 Nisqually earthquake shook the Puget Sound region. While the viaduct survived the earthquake, the quake damaged the viaduct's joints and columns, further weakening the structure.

Bracing was installed in the Pioneer Square area after the 2001 Nisqually earthquake.

Immediately after the earthquake, repairs were made to four sections of the viaduct in the Pioneer Square area near S. Washington Street. In 2001, WSDOT imposed roadway restrictions that remain in effect today; vehicles over 105,500 pounds are prohibited, and trucks and buses must travel in the right-hand lane.

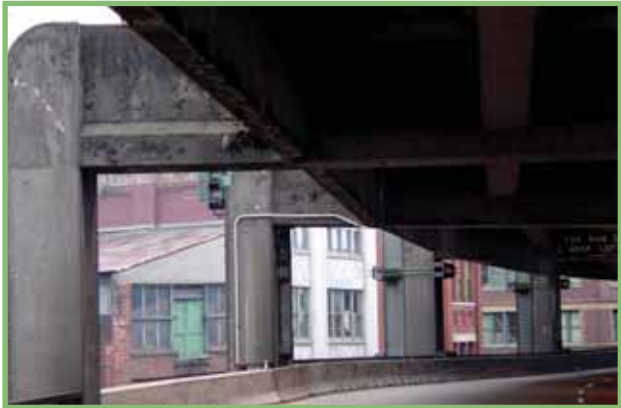
Since 2001, the viaduct has settled a total of five inches. The section near Columbia Street and Yesler Way across from the driving entrance to Colman Dock has experienced the most settlement.

This section of the viaduct between Columbia Street and Yesler Way is sinking.

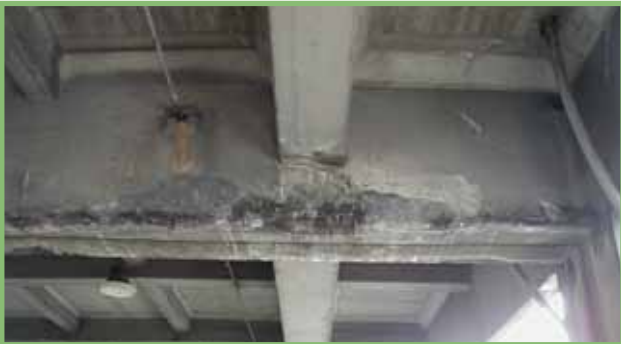
Example of exposed rebar.

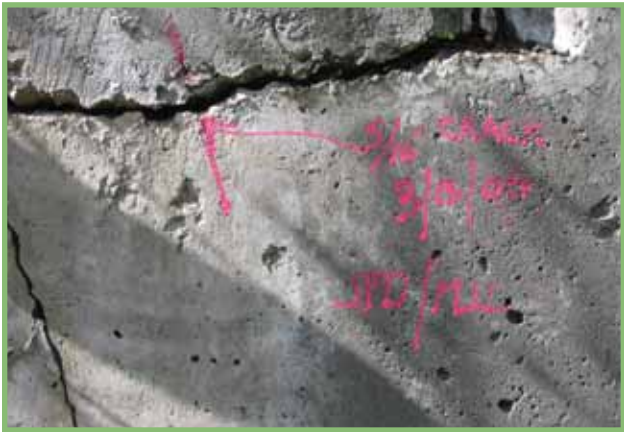
Structures that support the elevated viaduct are cracking.

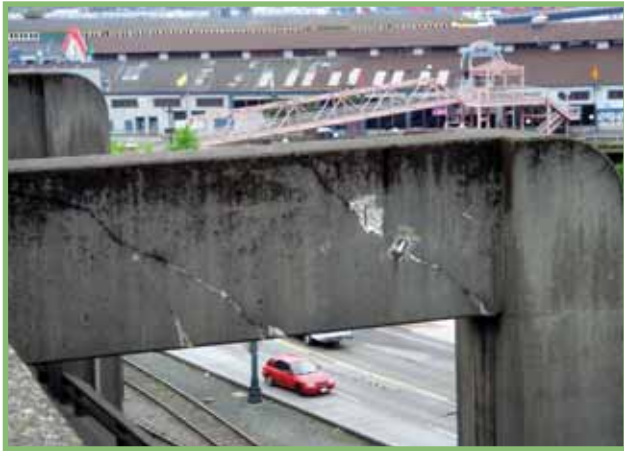
Increasing crack widths are a safety concern.
